HISTORIC STRUCTURE REPORT:
THE CUSTOM HOUSE AND TOWER

VOLUME II:
EXISTING CONDITIONS AND RECOMMENDATIONS

SARA B. CHASE
and
ANNE A. GRADY

SOCIETY FOR THE PRESERVATION OF
NEW ENGLAND ANTIQUITIES
CONSERVATION CENTER

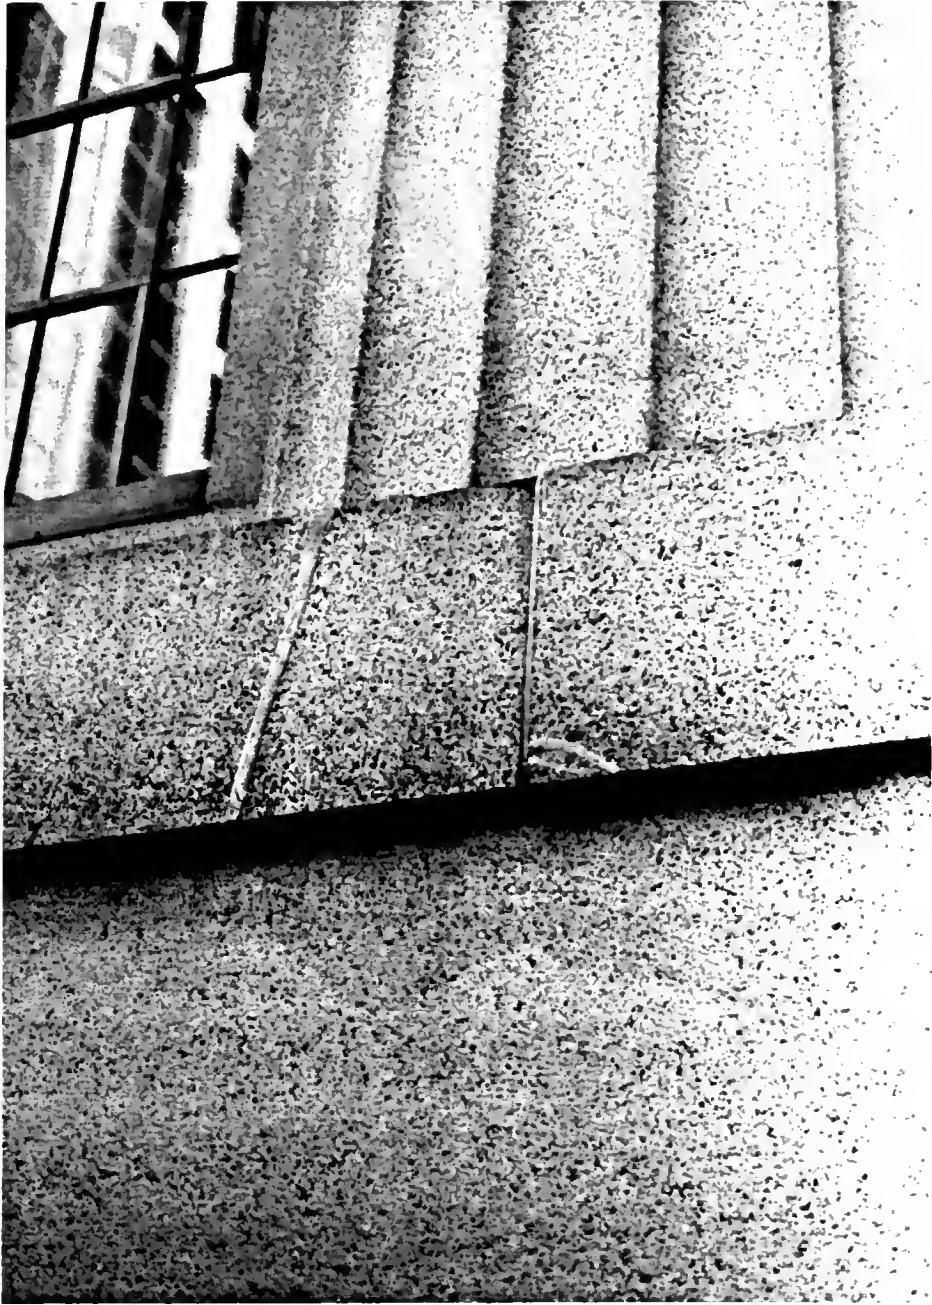
Figure 1

View of typical caulking in old crack

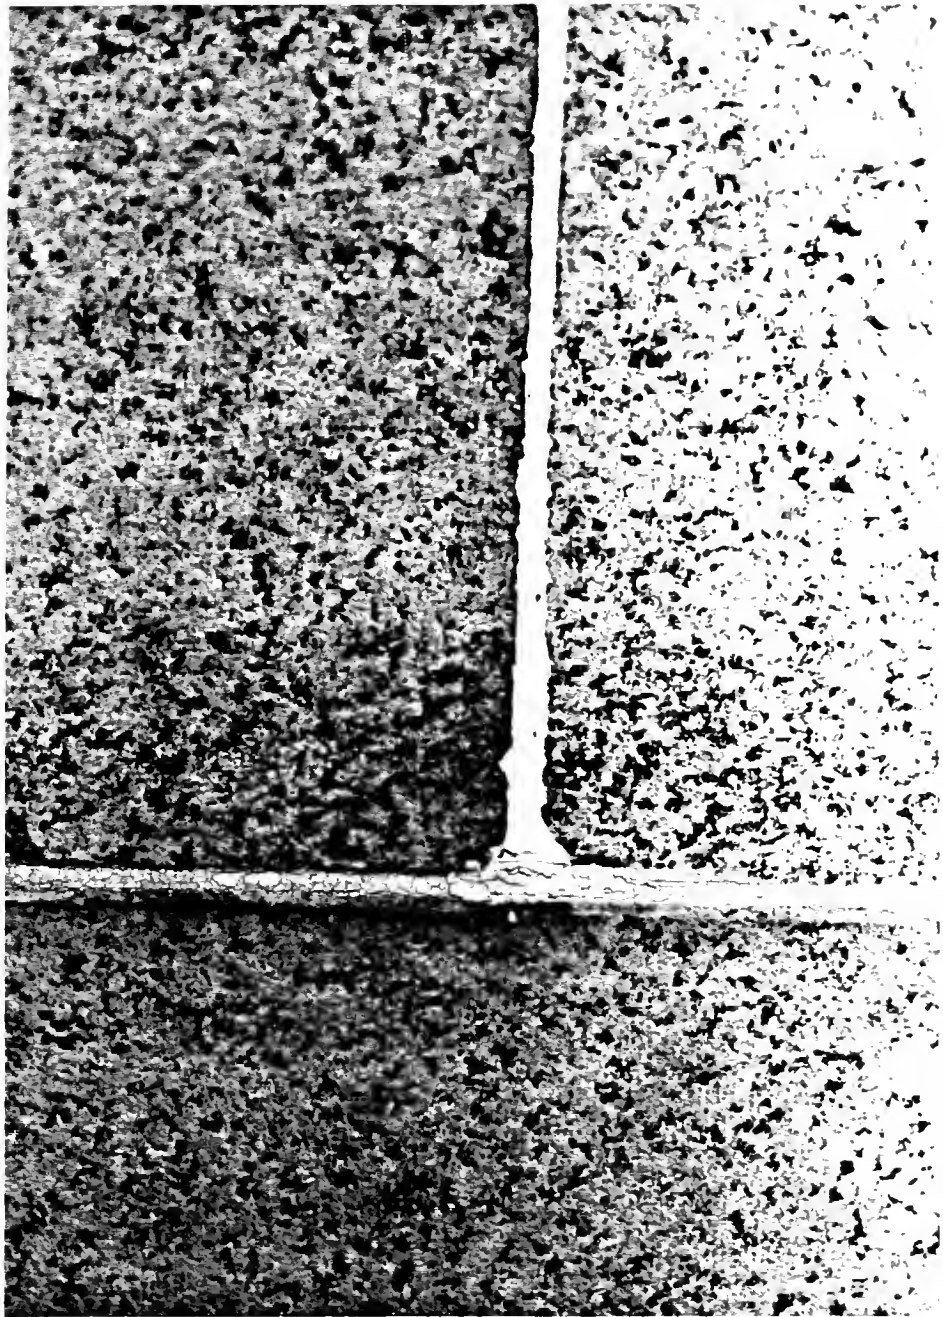
Figure 2

View of typical conditions of old 1970 caulk
and newer caulk in stone joints

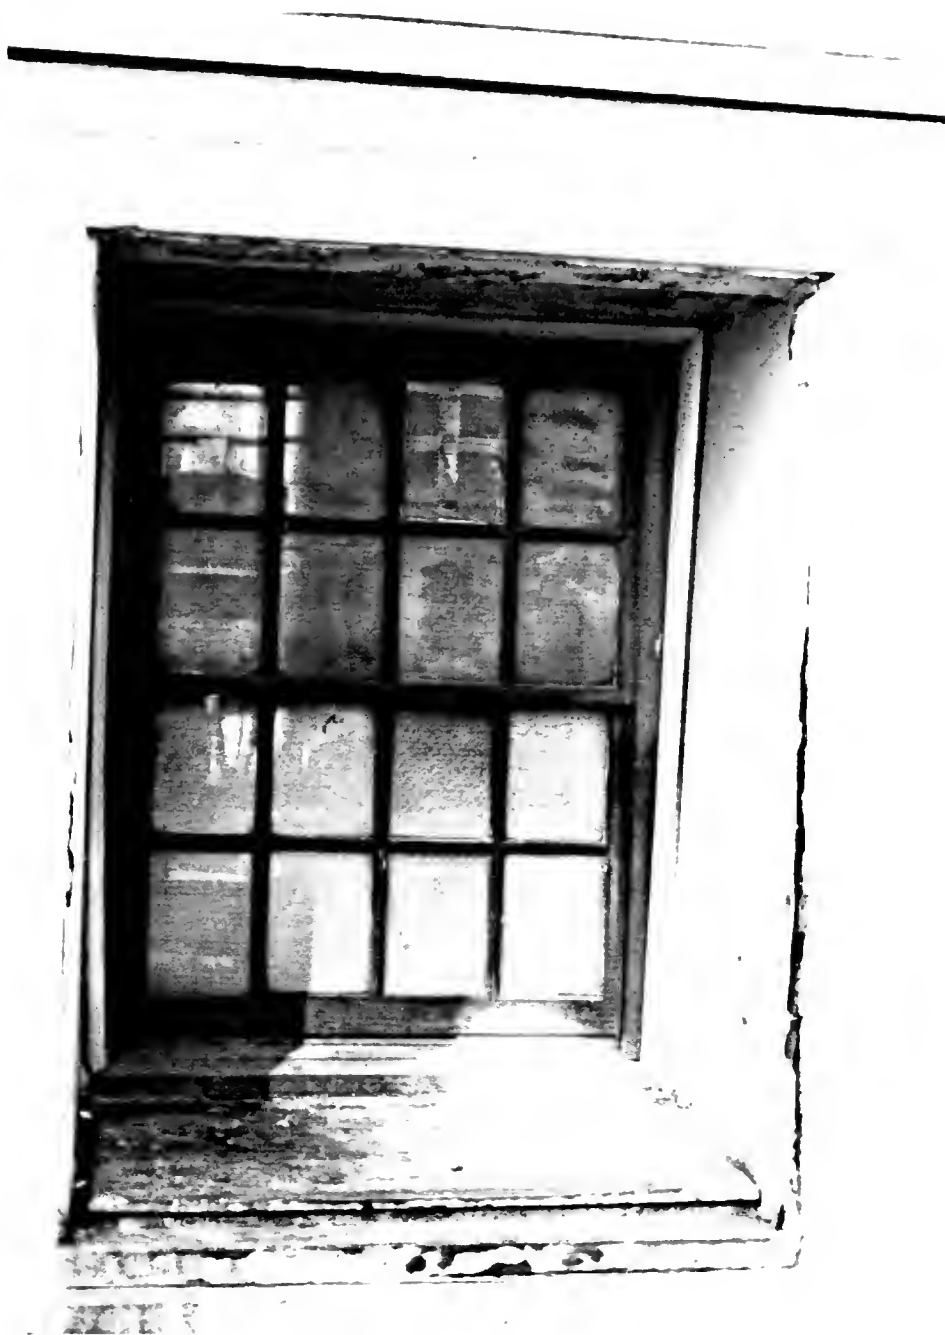
Figure 3

Basement window, East facade.
Typical conditions

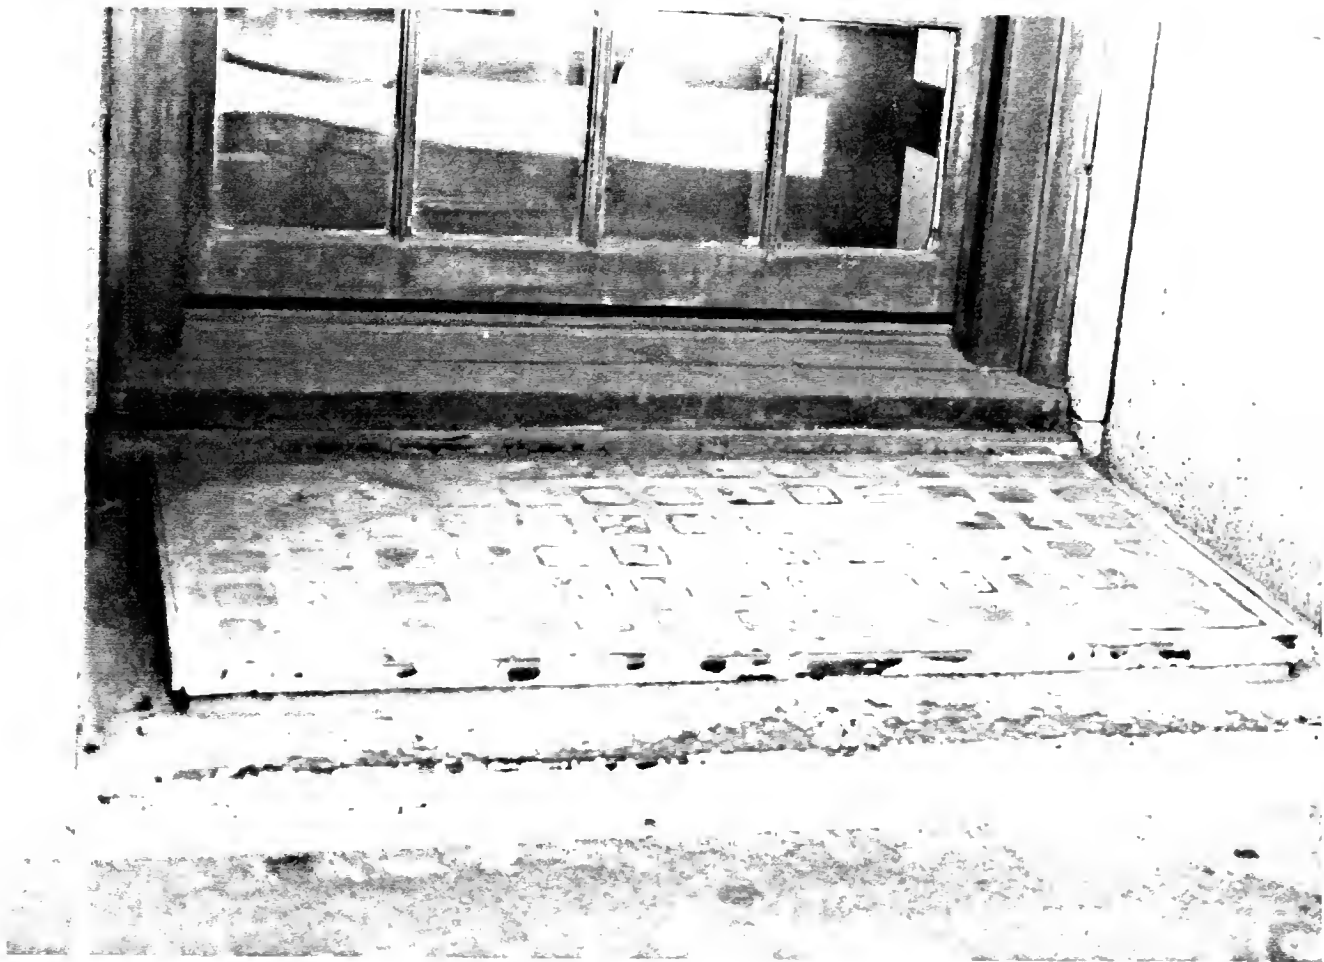
Figure 4

View of typical sub-basement
window well light grate

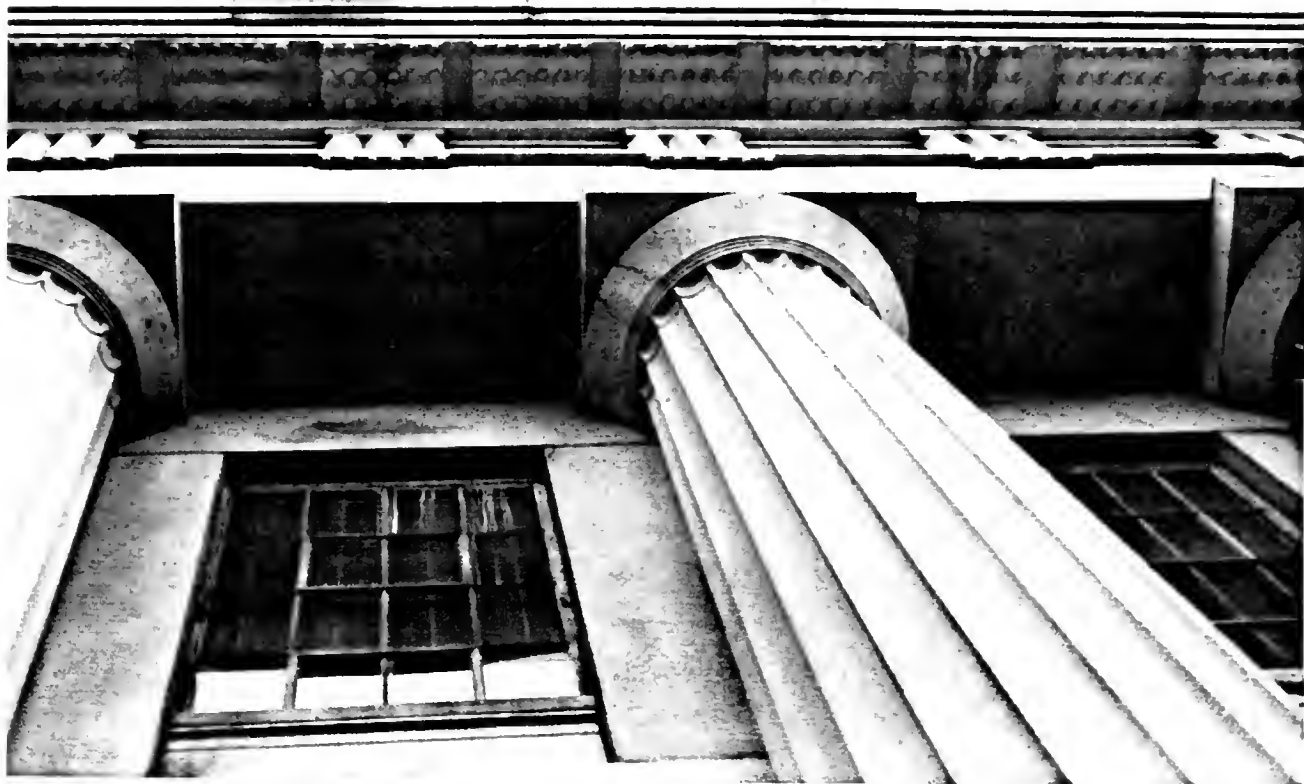
Figure 15

View of water stains in soffit,
Southern flank, East facade

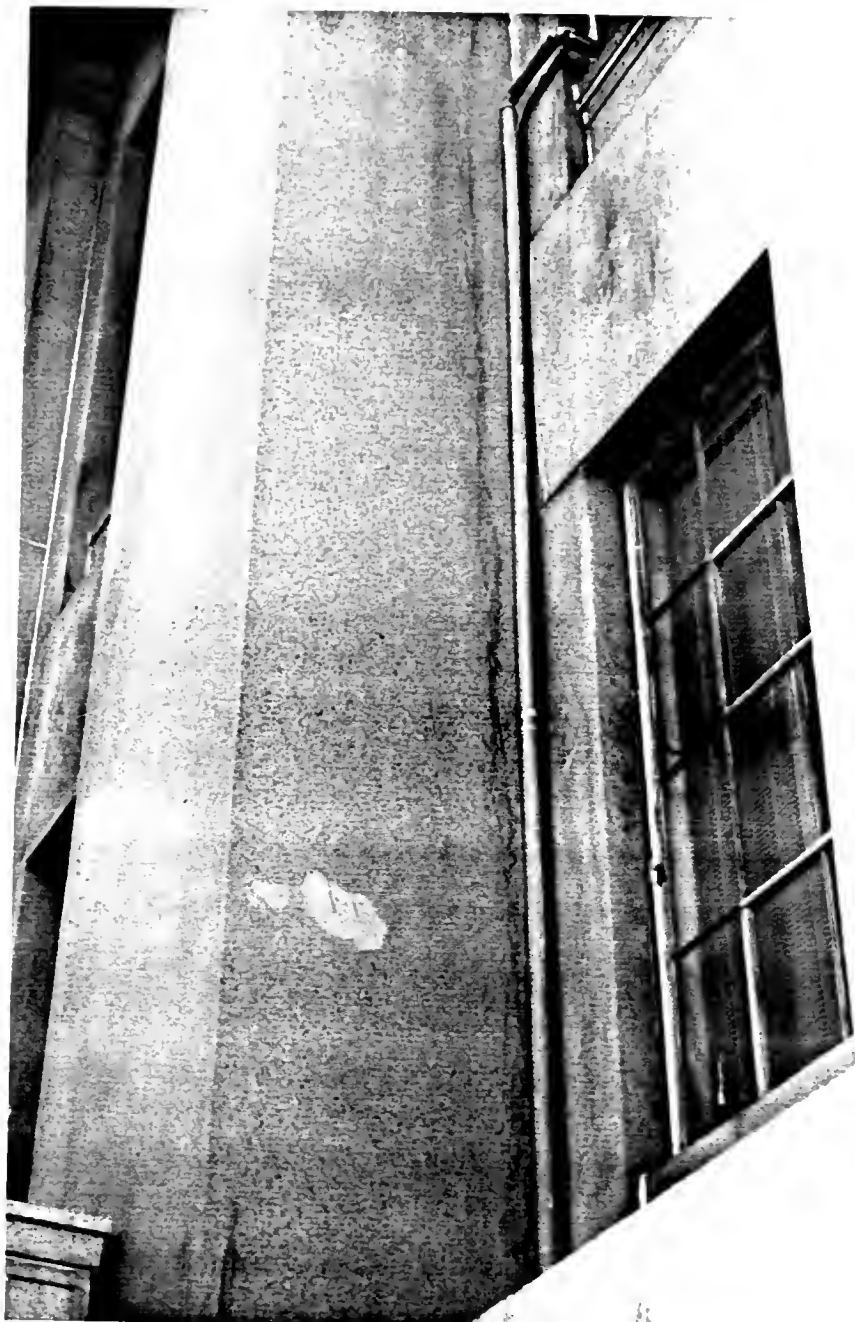
Figure 17

View of water stains, East facade,
North corner of portico

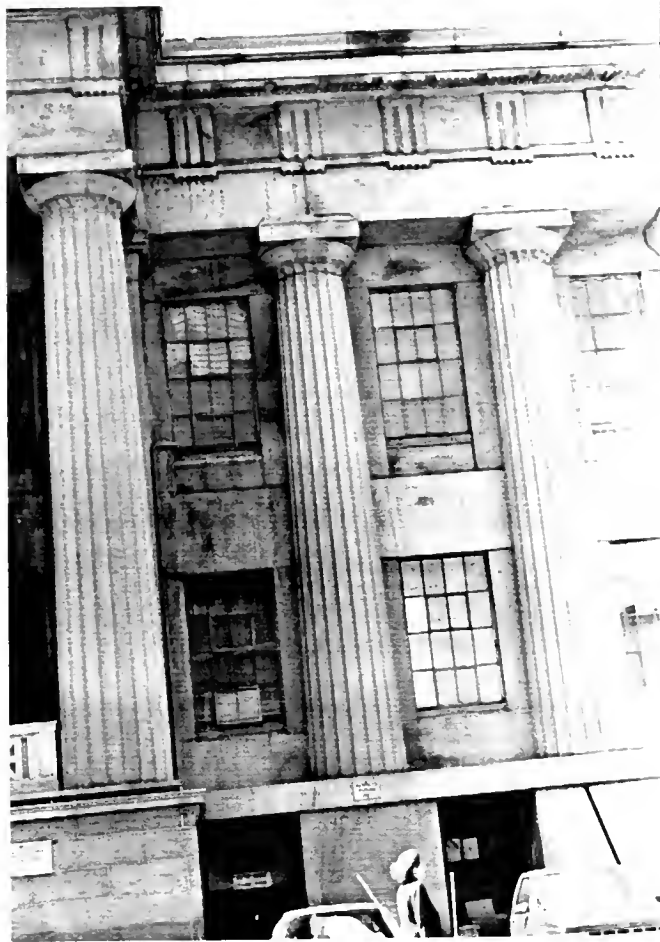
Figure 19

Northern side of East elevation.
Dark areas correspond with severe
interior water damage.

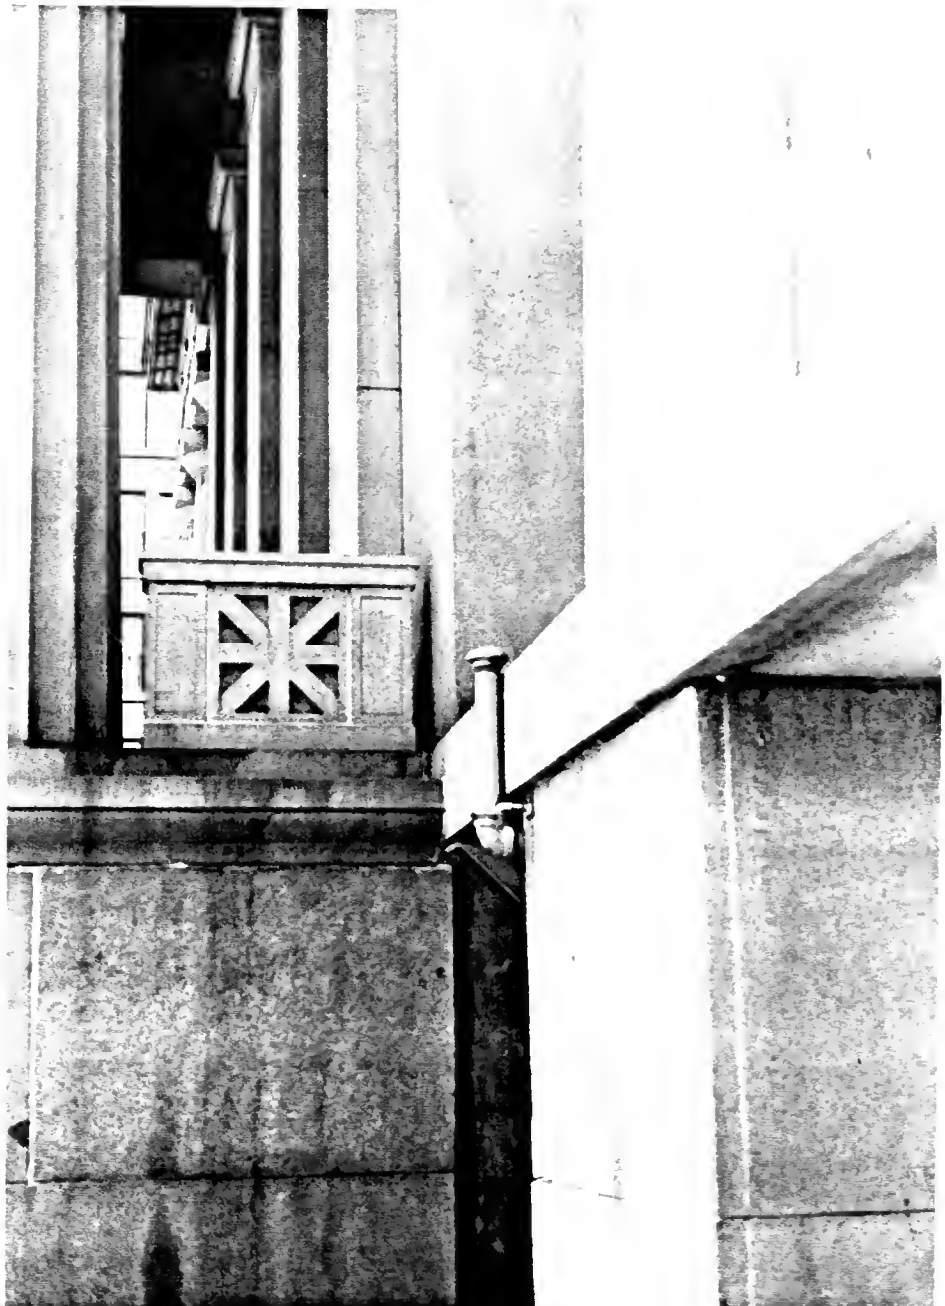
Figure 20

North corner of East portico first floor level
(dark water stains, poorly located vent)

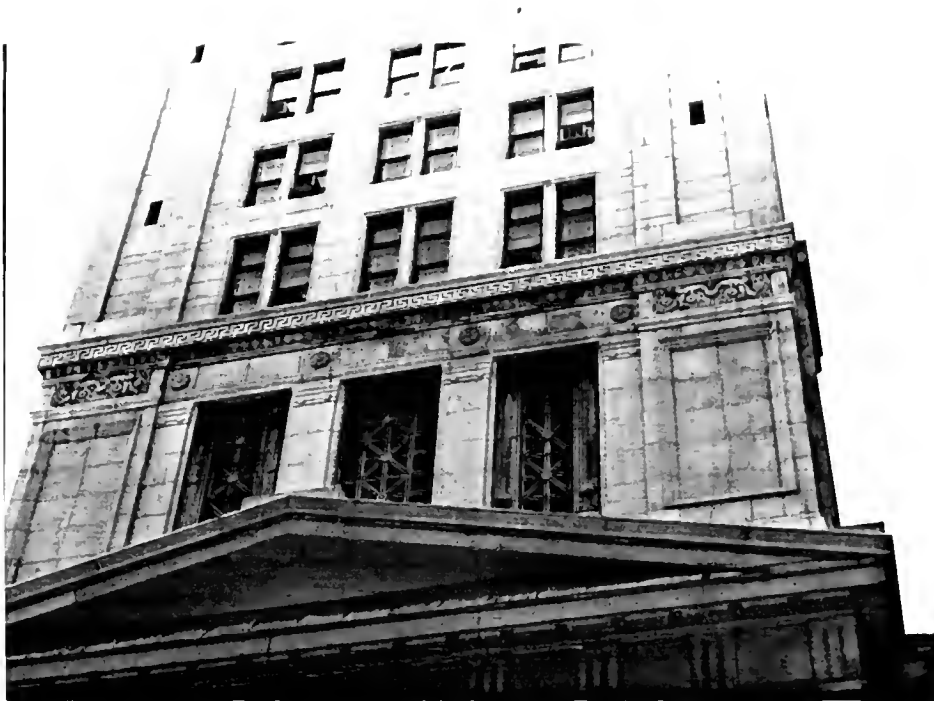
Figure 21

East wall. Dark areas correspond with
severe interior water damage.

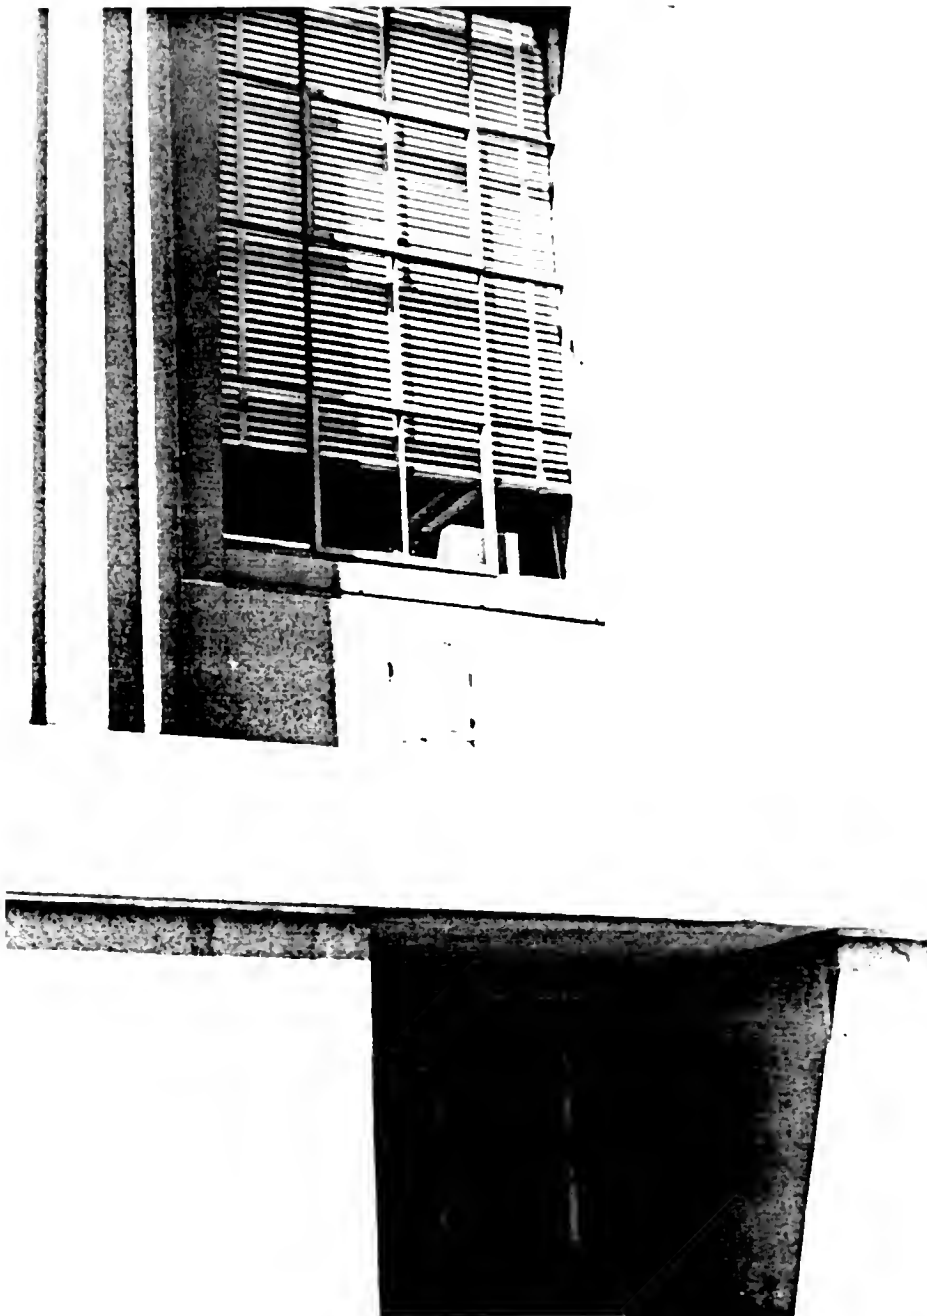
Figure 25

West side, South corner
Typical remnants of sign adhesive

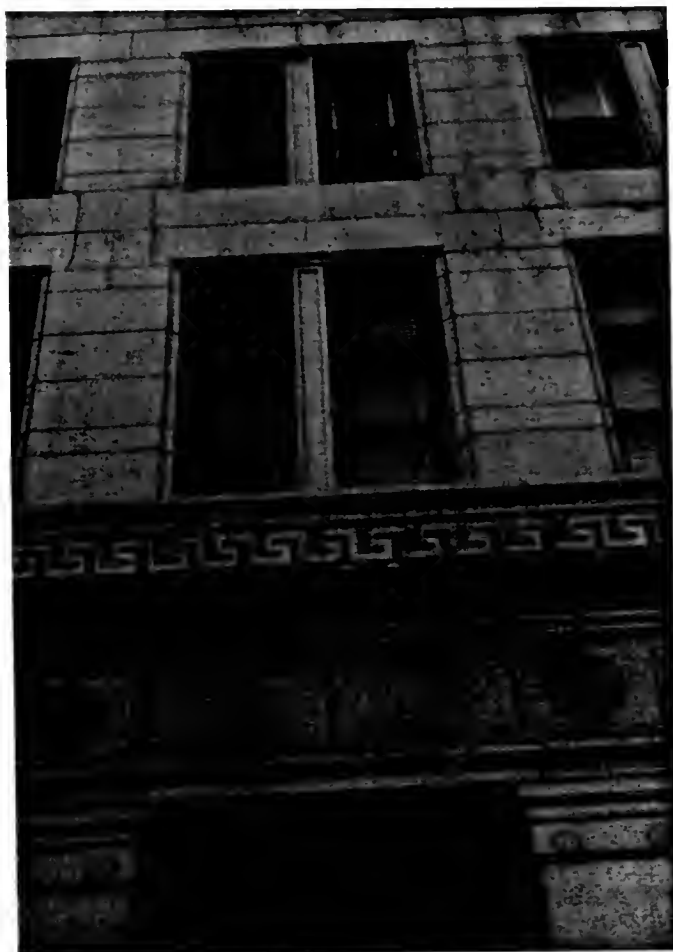
Figure 35

Stone conditions on North wall,
Floors 5 and 6

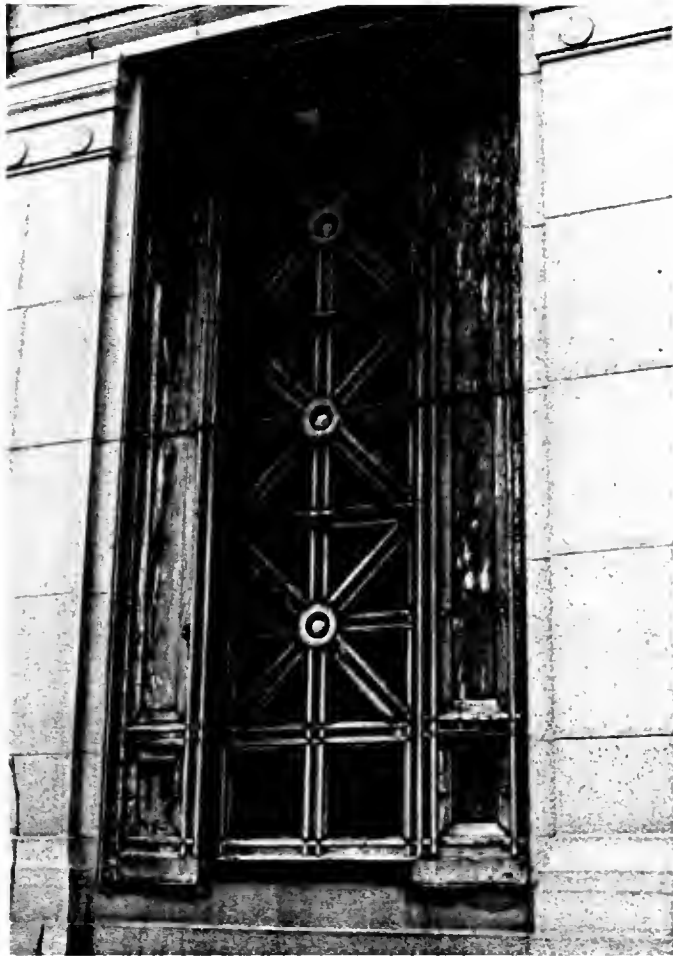
Figure 36

Typical condition of copper grille,
North side of tower

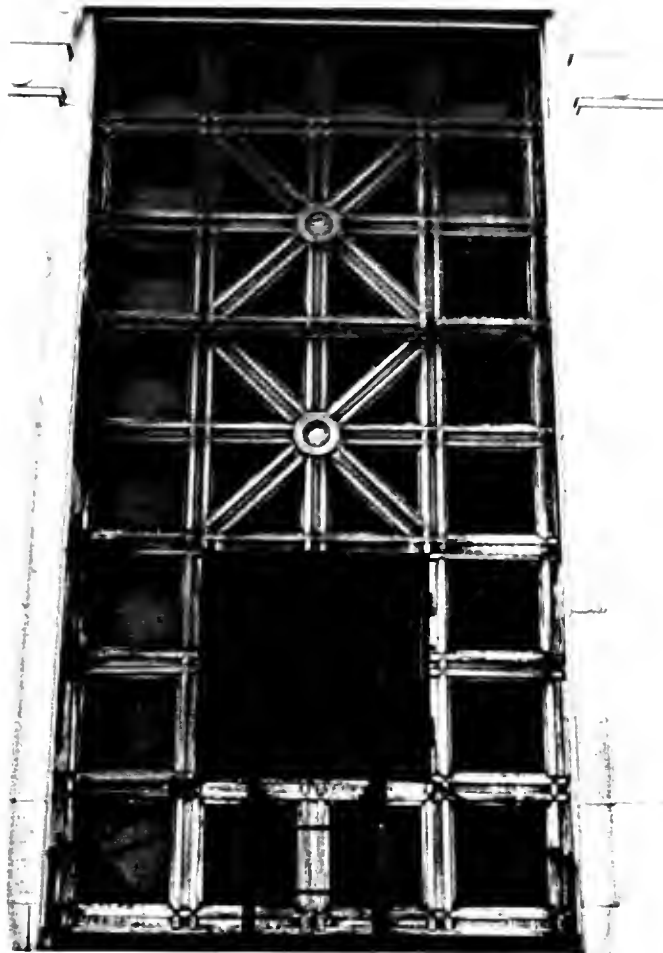
Figure 37

Hinged portion of copper grille missing
North wall, dome area

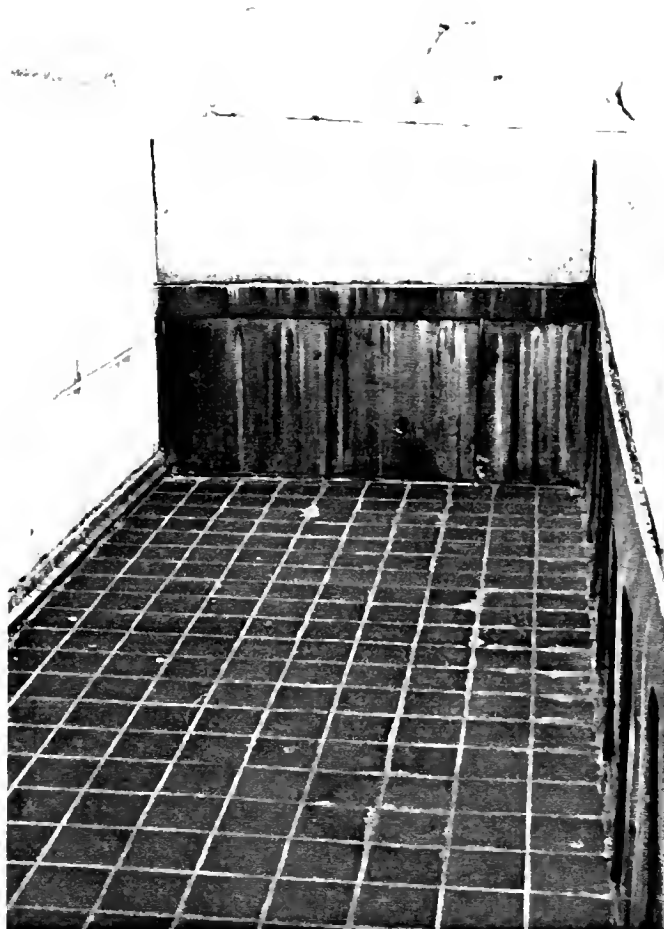
Figure 46

Copper cap and loose flashing,
East balcony, Floor 20

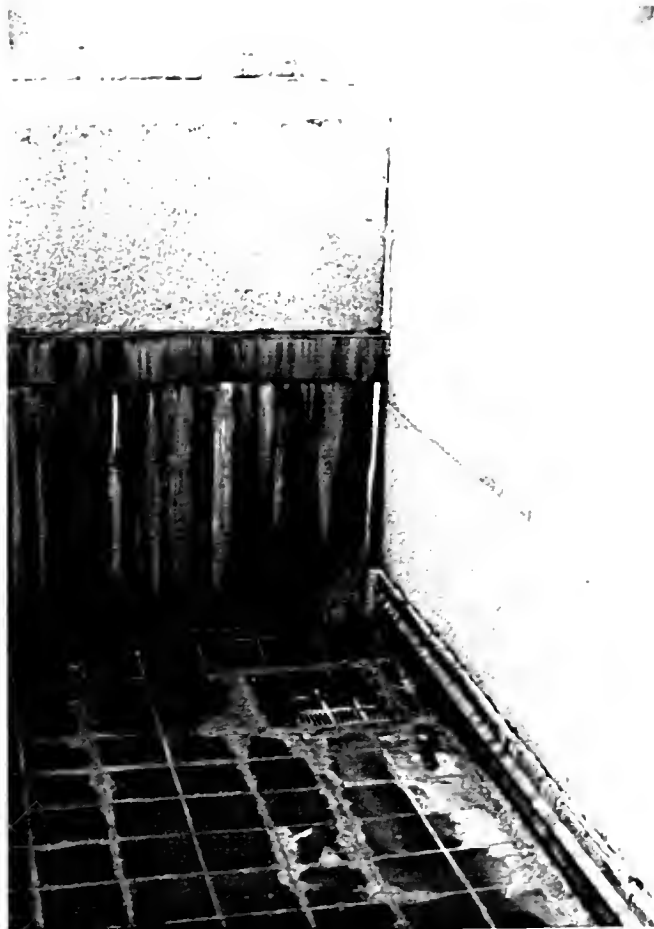
Figure 47

Drain in tile floor, Southeast corner of
East balcony, Floor 20. Clogged?

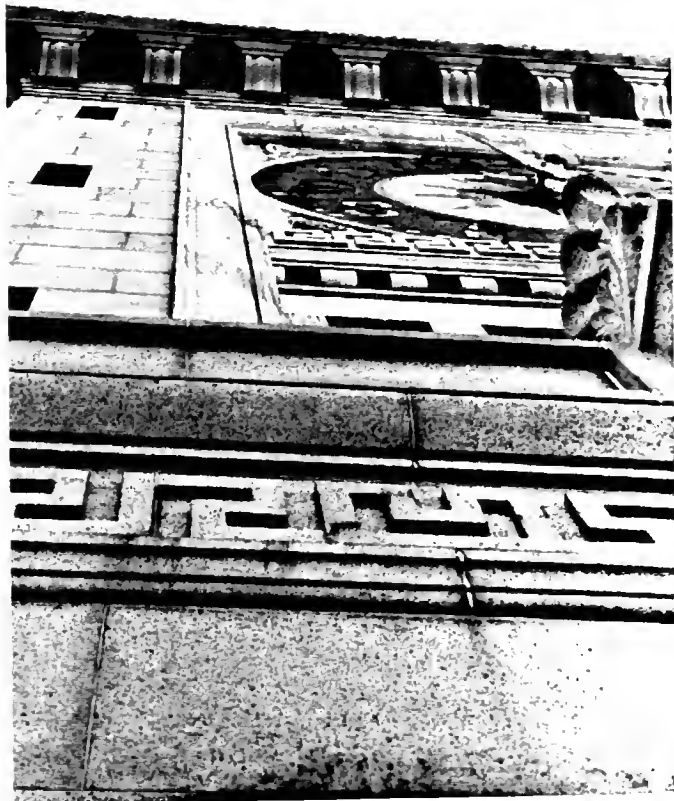
Figure 52

Clock face seen from West balcony, Floor 20
(Signs of dampness at joints)

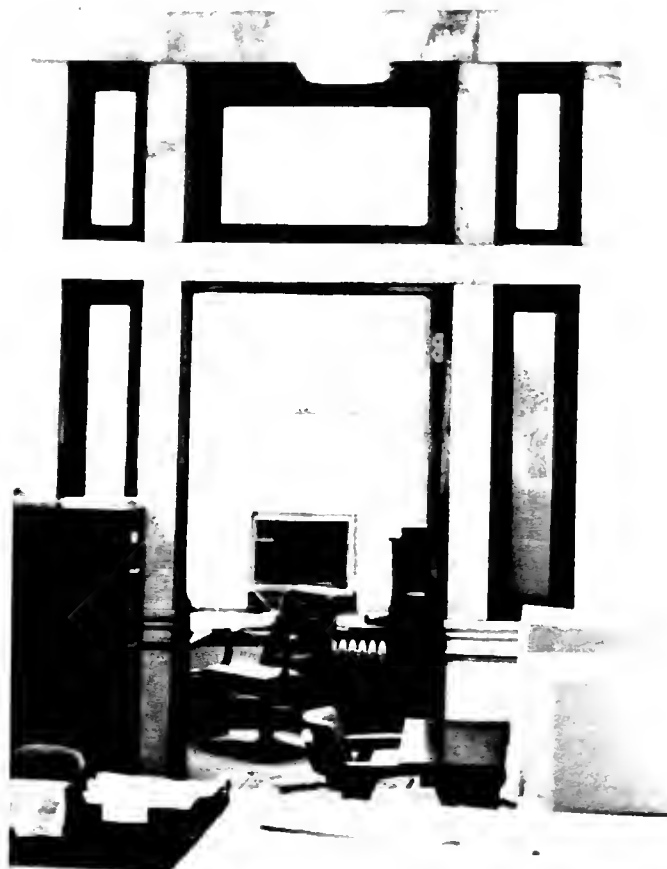
30 - View into office on west side of Auditor's Office showing typical frosted glass, grained metal frames, and marble surrounds, used in the more important offices.

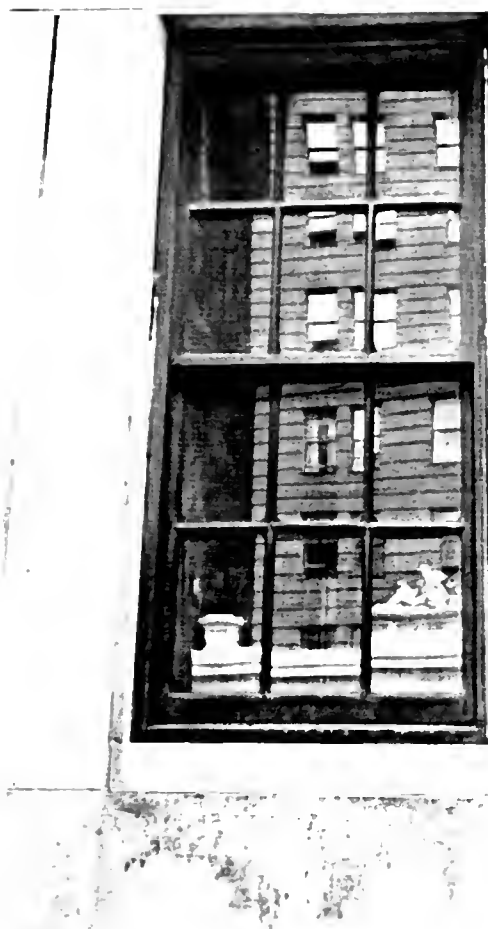
7 - Window to the north of west entry, main floor,
showing uneven stains and some black caulk.

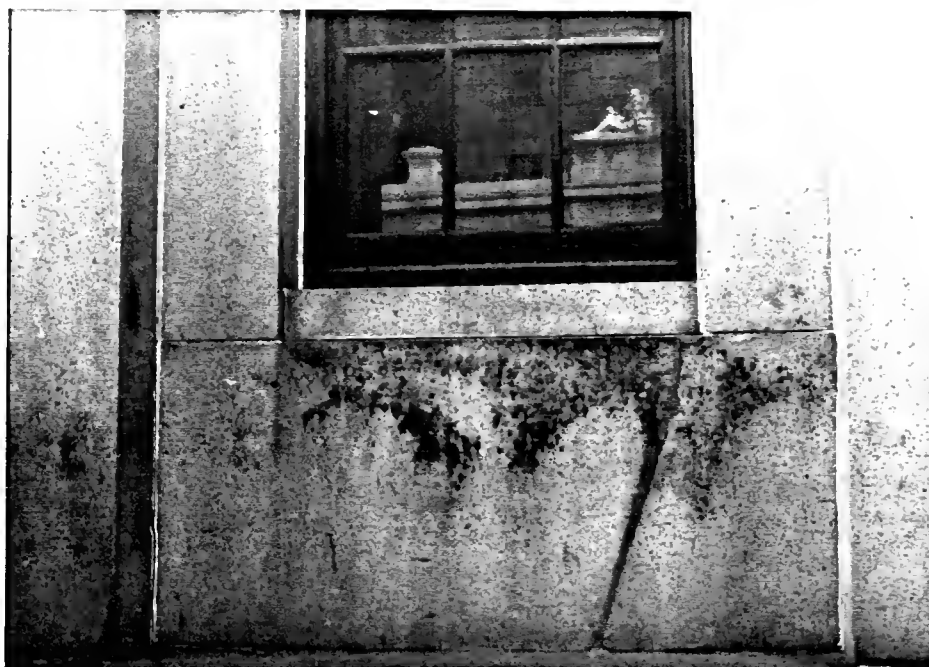
8 - Detail of window in Figure 7.

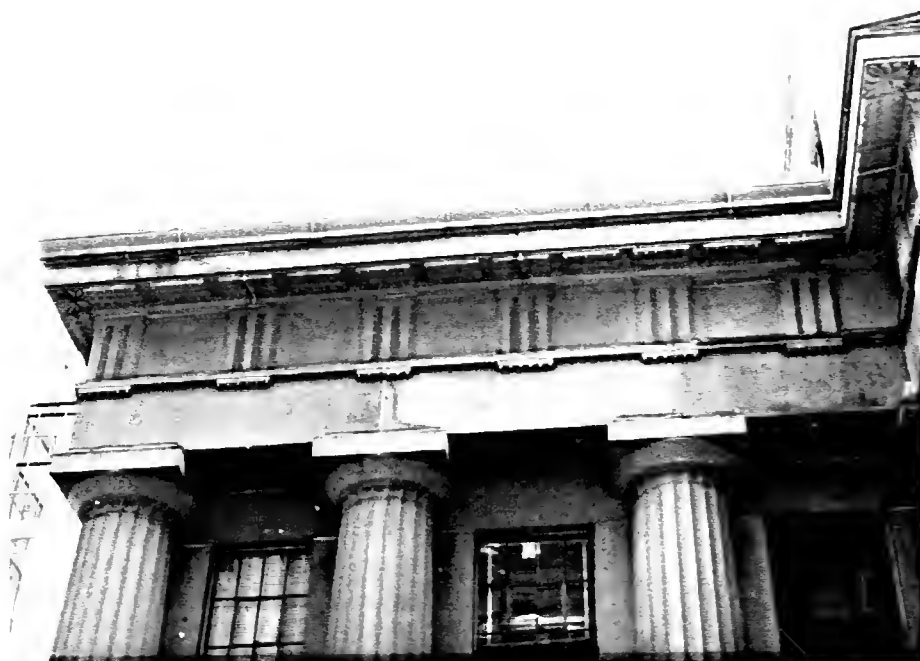
10 - View of architrave, frieze and cornice of northern side of west elevation, showing some water stains.

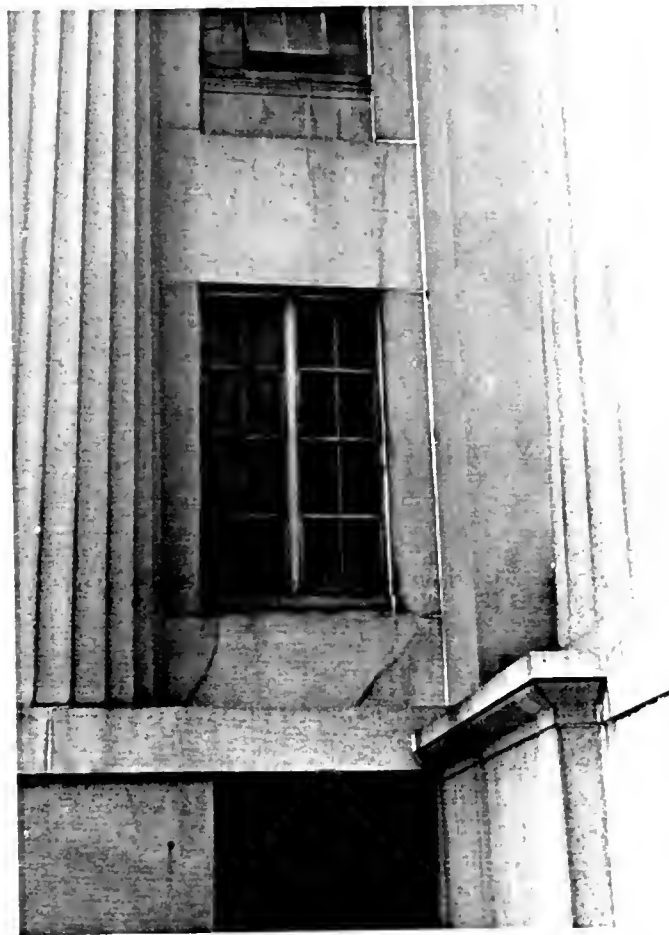
11 - View of 1949 windows and cracked grainte block on northern side of West elevation.

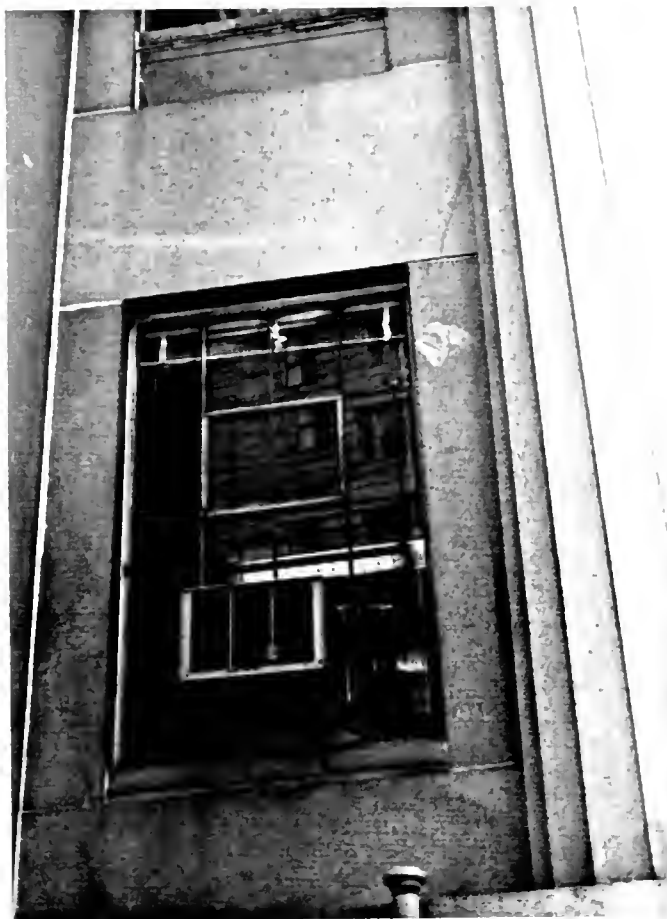
13 - View of 1949 office window, principal floor, to south of west entry, showing white caulk, vent stack and air conditioner (typical).

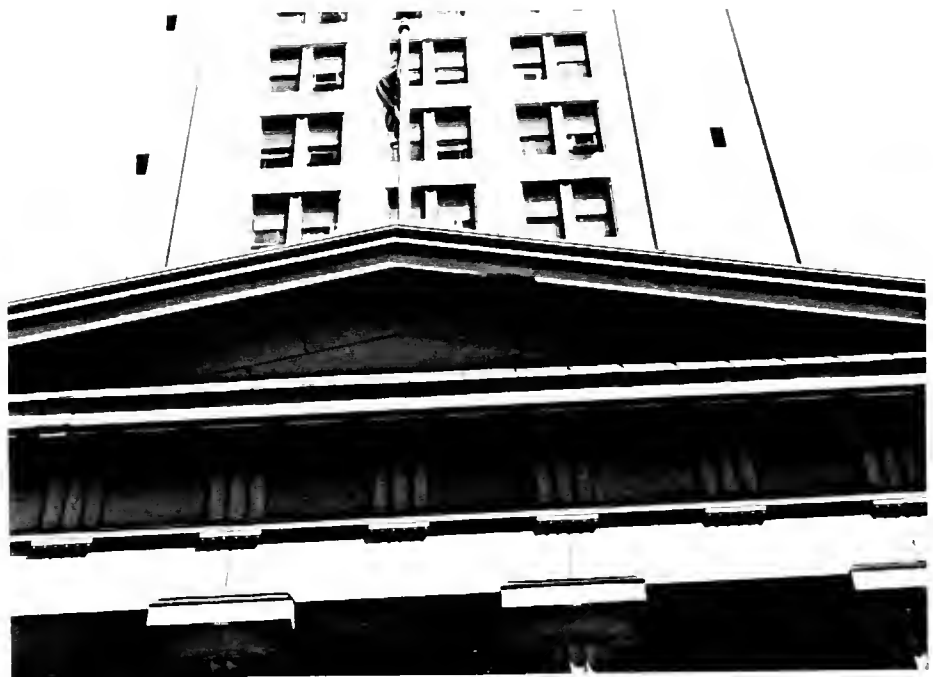
14 - South portico pediment, showing one small section of missing stone.

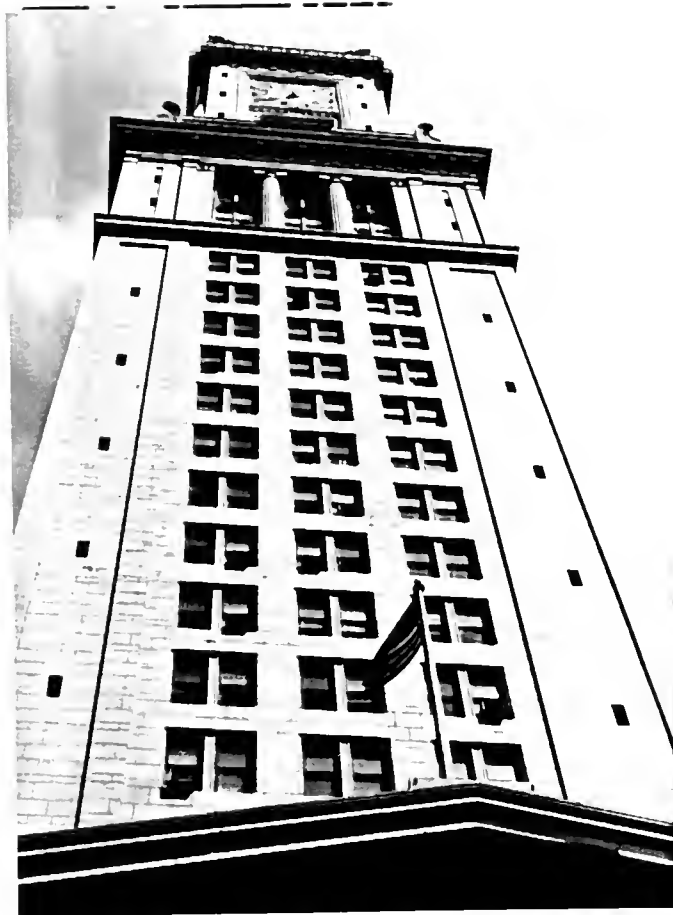
15 - South elevation of Tower, showing dark mortar,
lighter replacement corner blocks.

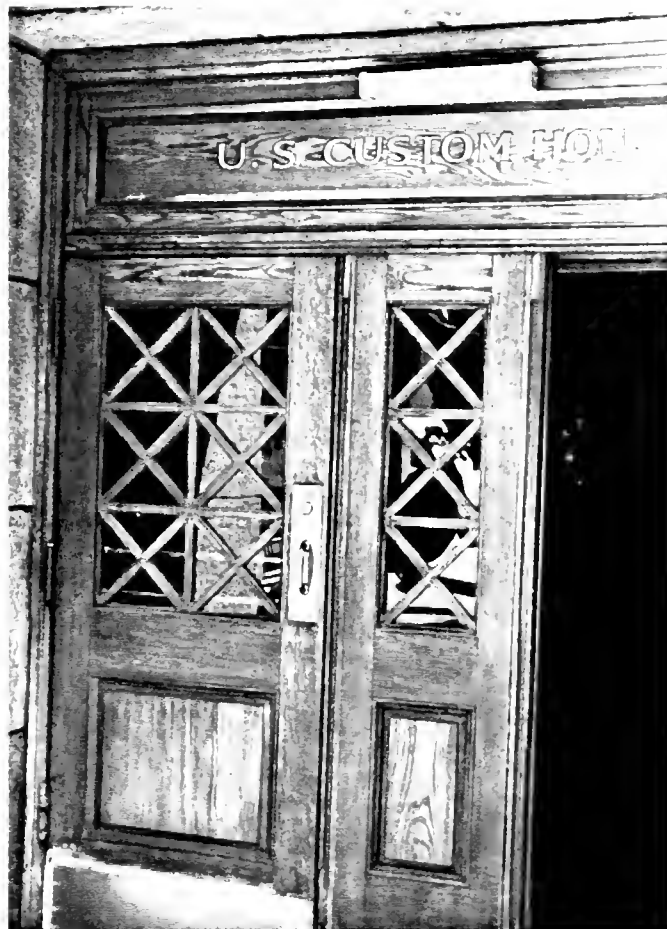
16 - Doorway to ground floor, south entrance, Peabody and Stearns (except for light fixture). Brass polish has damaged wood; wood needs refinishing.

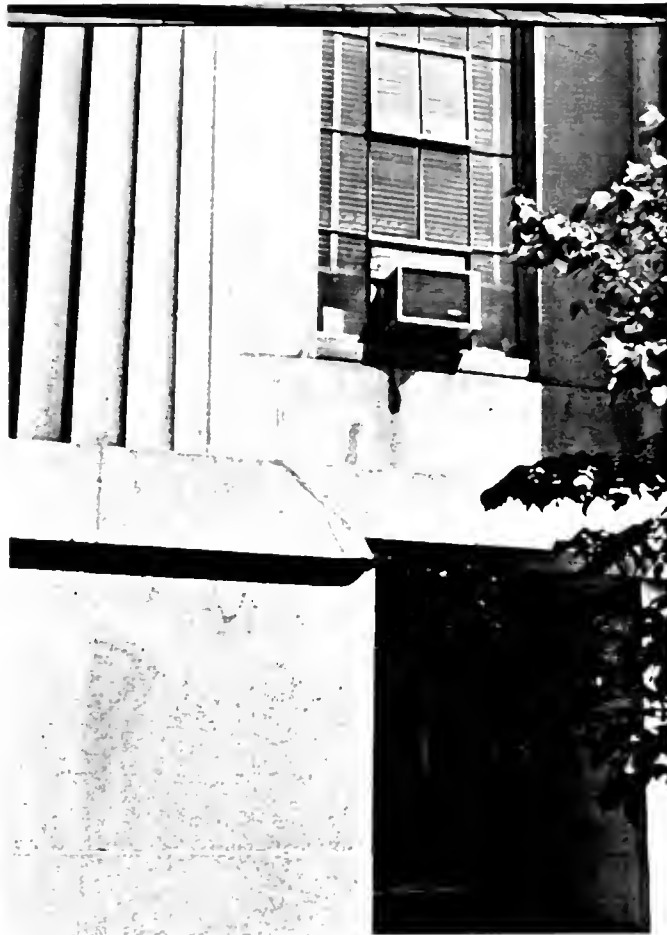
17 - Window to the east of south entrance, ground floor;
typical conditions.

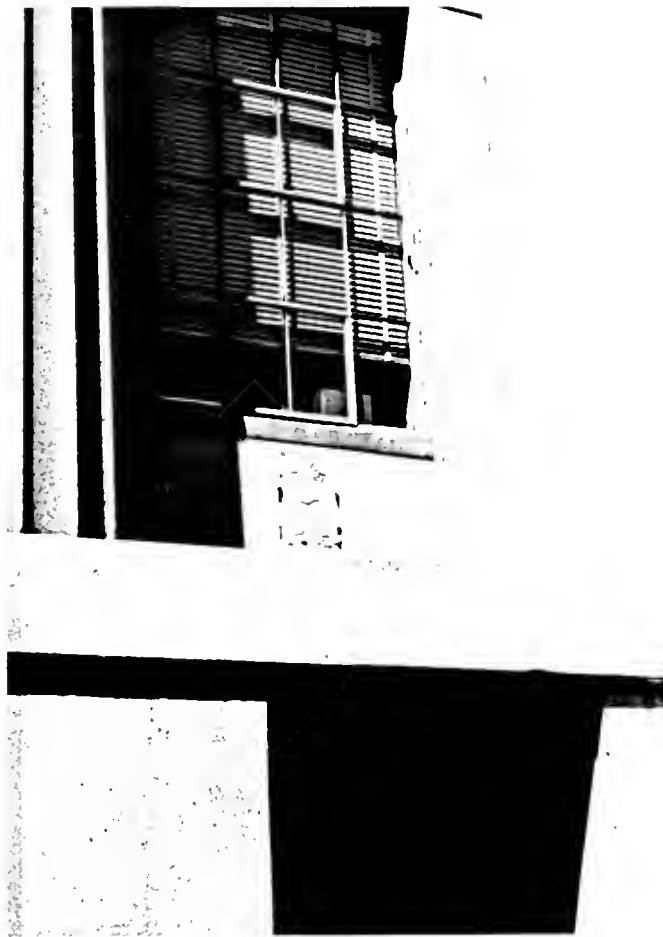
19 - South elevation, typical 1949 window, old mortar from sign, to be removed.

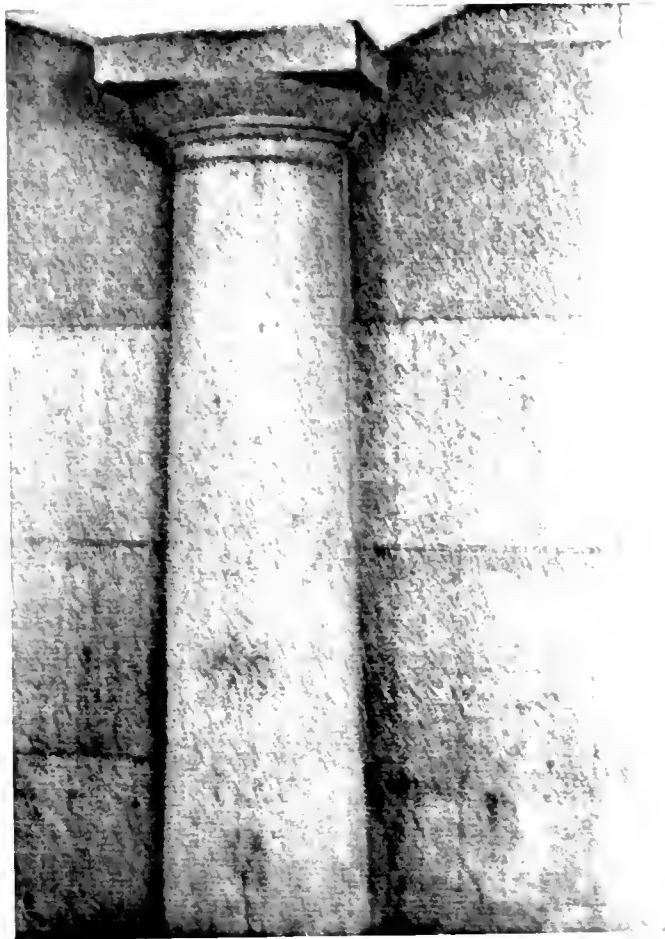
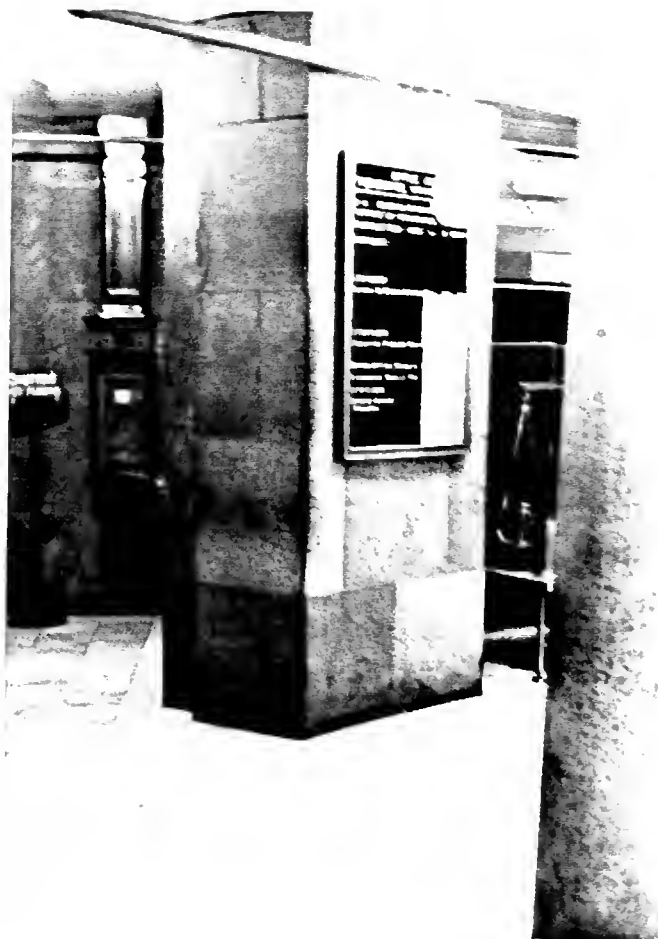
22 - Views of Young's granite columns and walls on the basement floor (street level), showing typical conditions: oily and black stains from hands at about three to four feet from the floor; blackened areas at the base from floor waxes.
